Docket No. 217 – Development and Management Plan Inspection

Northeast Utilities Service Company Certificate of Environmental Compatibility and Public Need for the construction of a 345-kV electric transmission line and reconstruction of an existing 115-kV electric transmission line between Connecticut Light and Power Company's Plumtree Substation in Bethel, through the towns of Redding, Weston, and Wilton, and to the Norwalk Substation in Norwalk, Connecticut.

Date: January 08, 2004

Location: Norwalk Substation Expansion

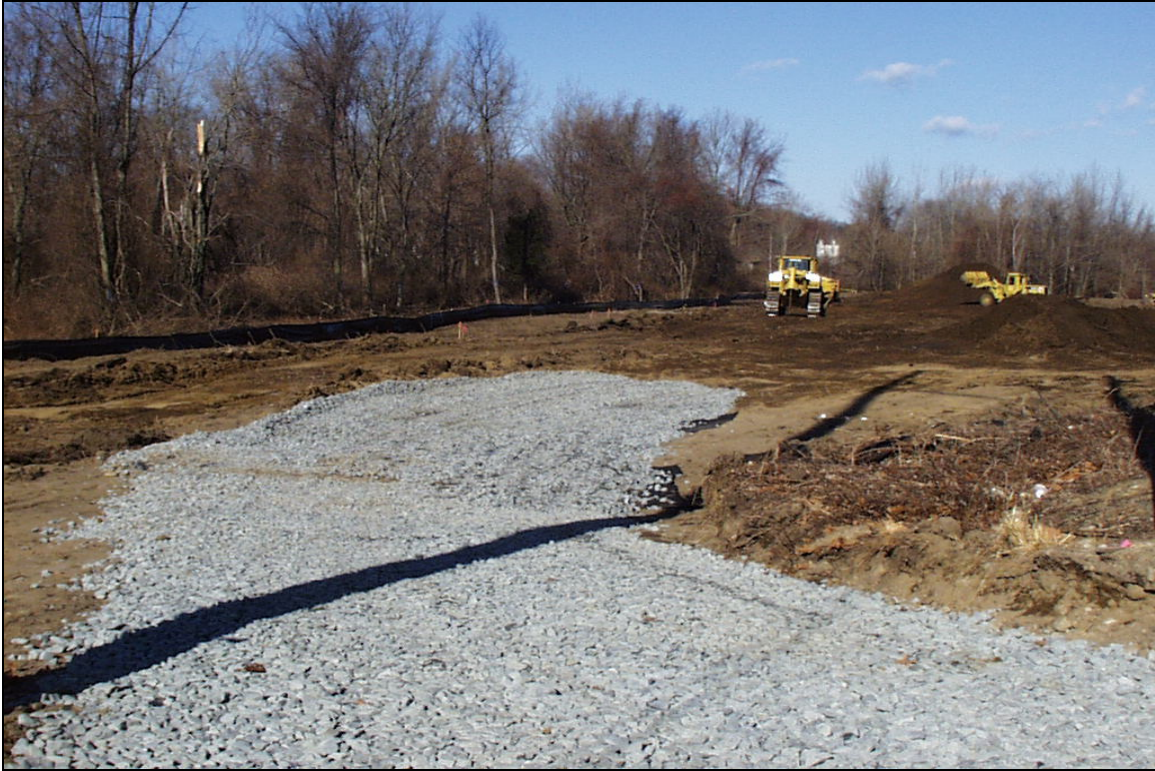
Areas of Inspection	Observation	Recommended Action
Access Roads	- The access road leading from the Route 7 ramp to New Canaan Ave is being developed. The freezing conditions have helped to firm up the ground and pads of stone have been placed in select locations. 1/08/04	- None at this time. Continue to monitor. 1/08/04

VIEW OF THE NEW STONE PADS PLACED WITHIN THE DEVELOPING ACCESS ROAD. IN THE BACKGROUND, EXCAVATION IS BEGINNING ON THE TEMP SEDIMENT BASIN 1/08/04

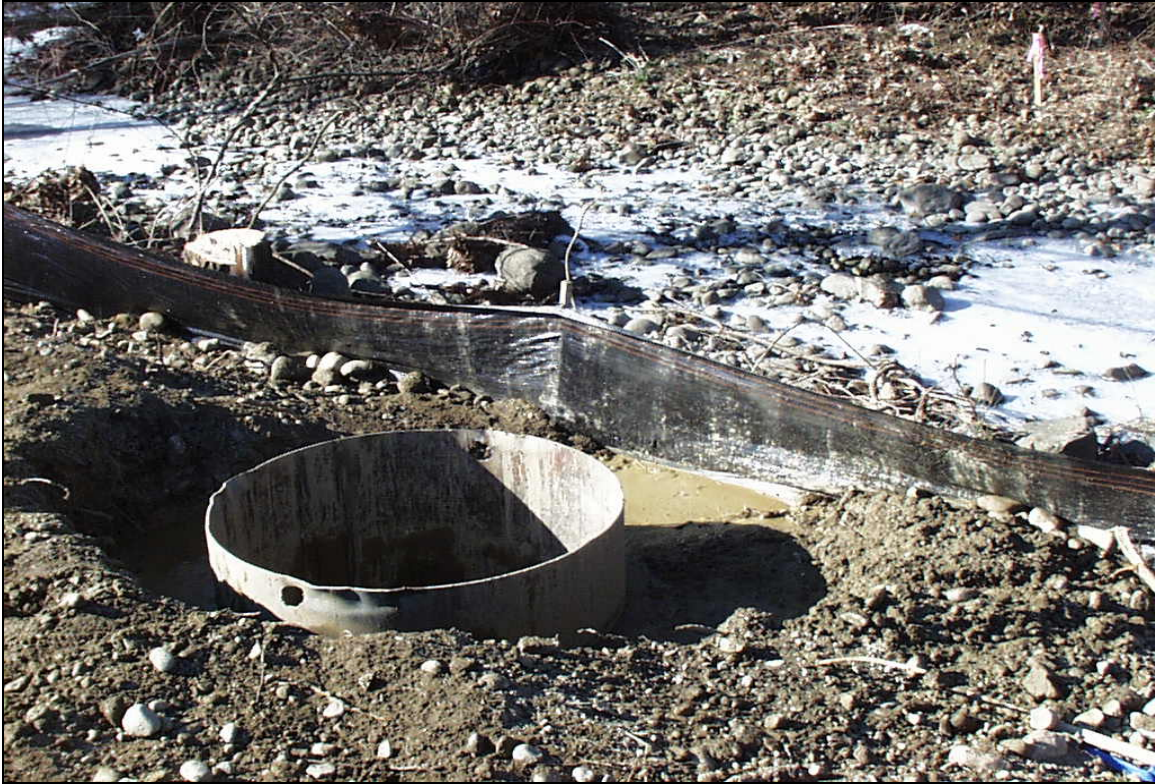
- Silt fence has been installed along the entire wetland line between the resource areas and work areas. It is toed in well and is effectively preventing sediment from entering the river. 1/08/04	- Continue to monitor and maintain as needed. Some spots are very close to the river and will require the most monitoring. Keep up with silt fence repair as needed and be proactive 1/08/04

VIEW OF ONE OF THE CAISSONS PLACED IN THE NEWLY CLEARED AREA.
SILT FENCE HAS BEEN INSTALLED ALONG THE ENTIRE WETLAND
BOUNDARY AND IS WORKING WELL. 1/08/04

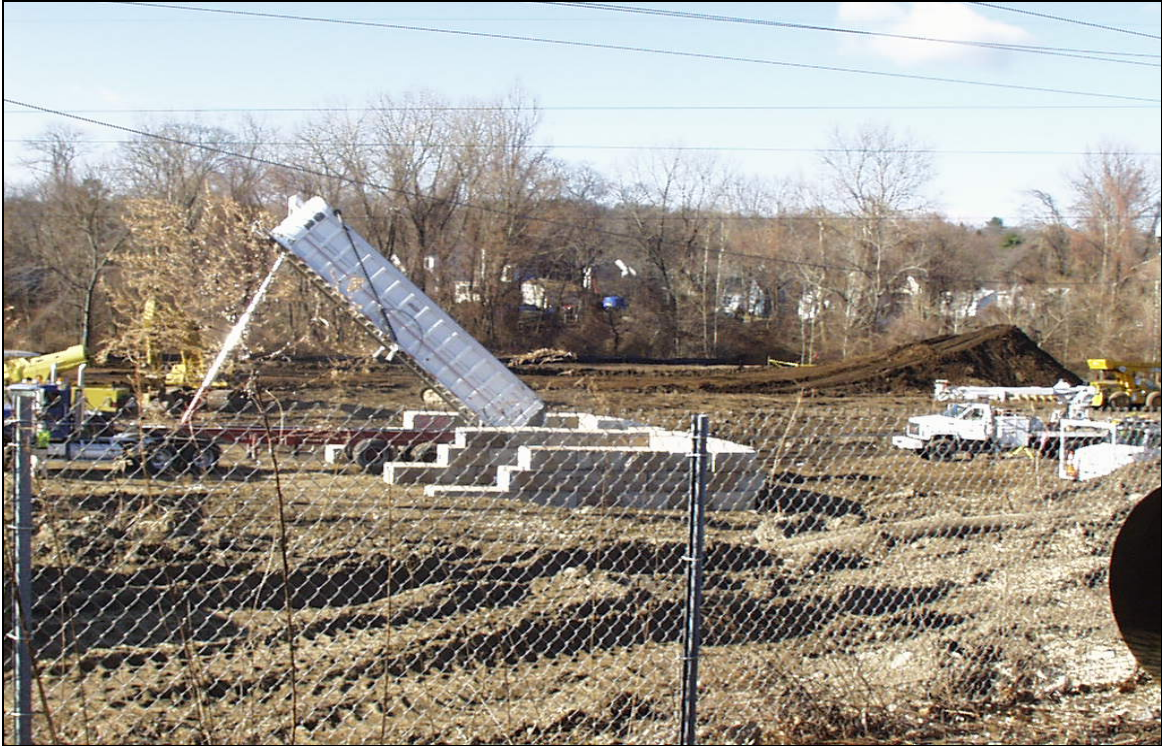
OVERALL VIEW OF THE YARD INCLUDING THE STONE SEPARATOR AND
THE TOPSOIL STOCKPILE IN THE BACKGROUND. 1/08/04

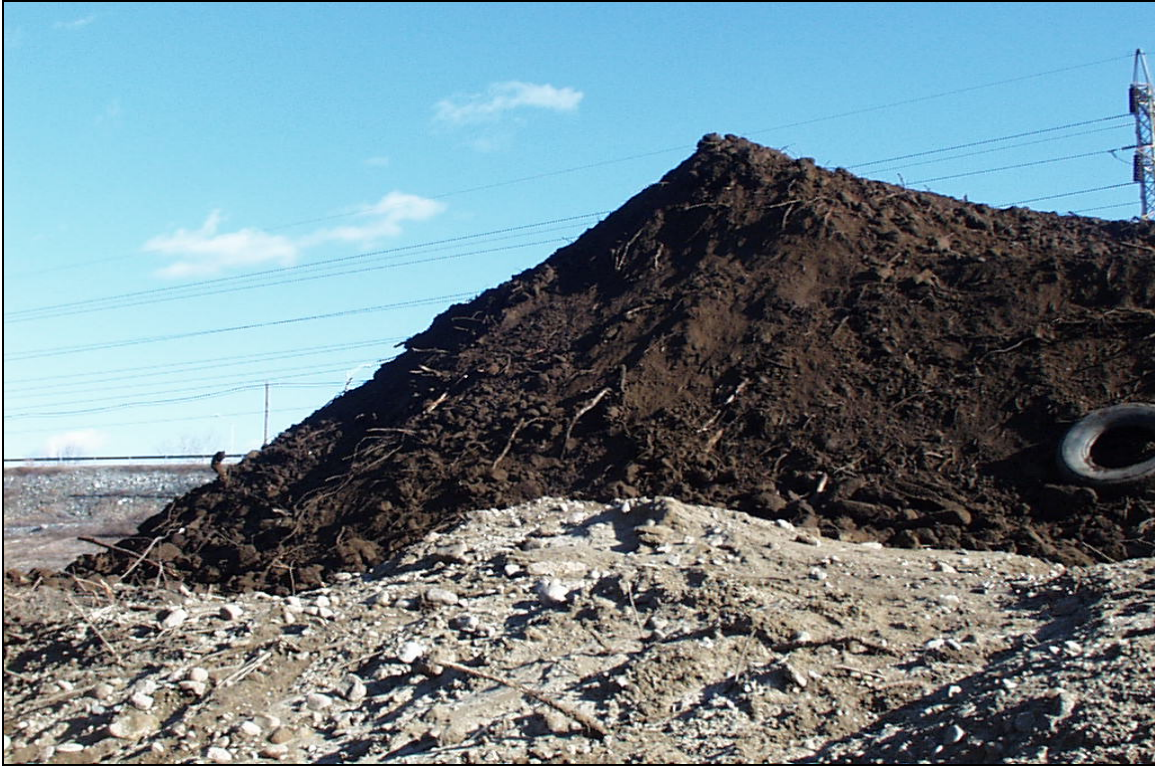
- Topsoil is being stockpiled in large amounts and is contained by the outer barrier of silt fence at this time. 1/08/04	- A second silt fence barrier around the downgradient side of stockpile itself is highly recommended due to its location and potential to reach the river. This is also required by the permits. 1/08/04

VIEW OF TOPSOIL STOCKPILE. IT IS WELL CONTAINED WITHIN THE OUTER SILT FENCE BUT A SECOND BARRIER IS HIGHLY RECOMMENDED AT ITS BASE DUE TO PROXIMITY AND A SLIGHT GRADIENT TO THE RIVER 1/08/04

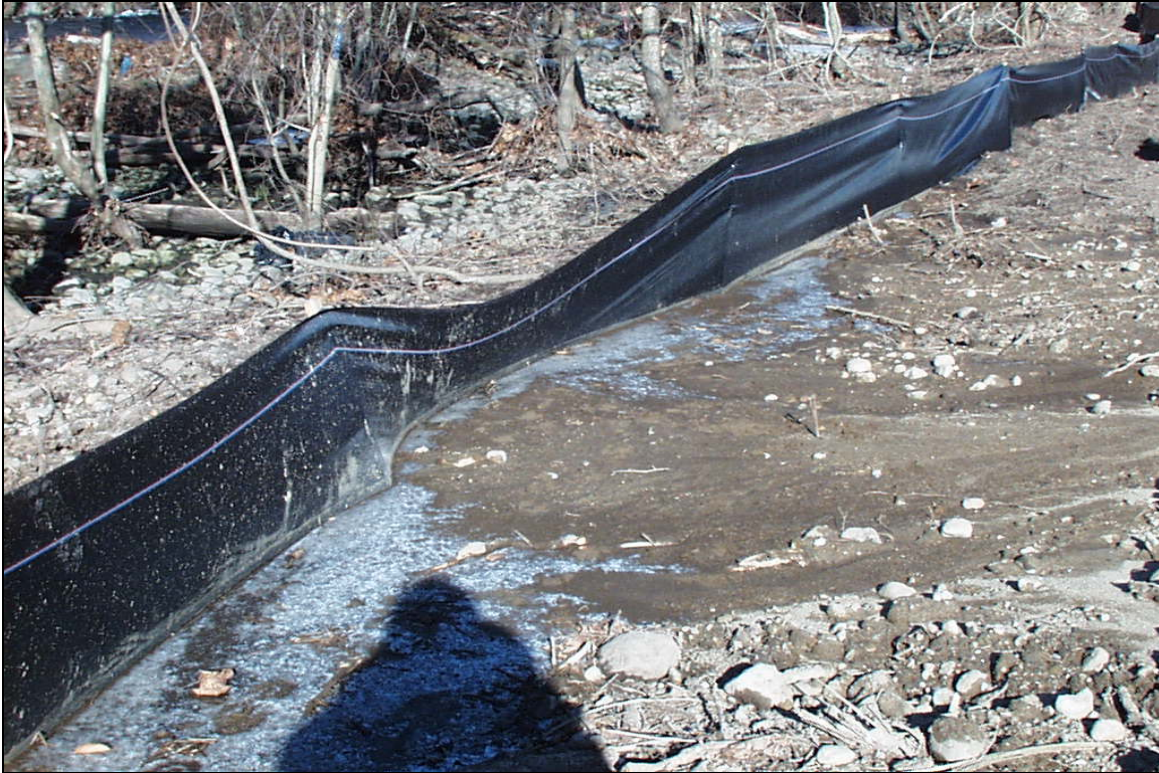
- The freezing conditions have helped stabilize the entire yard and existing access road and ROW. 1/08/04	- None at this time. Watch the area when thawing occurs and determine whether timber mats should be used. 1/08/04
Foundation construction	- Several caissons have been placed in the newly cleared area in order to relocate poles. 1/08/04 - Digging these holes had caused some water and wet soil to be deposited nearby. It was all contained by silt fence. 1/08/04	- One caisson in particular is close to the silt fence and the river. The silt fence is under some minor strain from the sediment placed from digging the hole. Continue to monitor the spot and either reinforce or repair if more strain becomes apparent. 1/08/04

VIEW OF A SPOT SHOWING STRAIN IN THE NEW SILT FENCE DUE TO
SEDIMENT DEPOSITS FROM THE
CAISSON PLACEMENT. THIS SPOT
SHOULD BE REPAIRED WHEN
NECESSARY 1/08/04

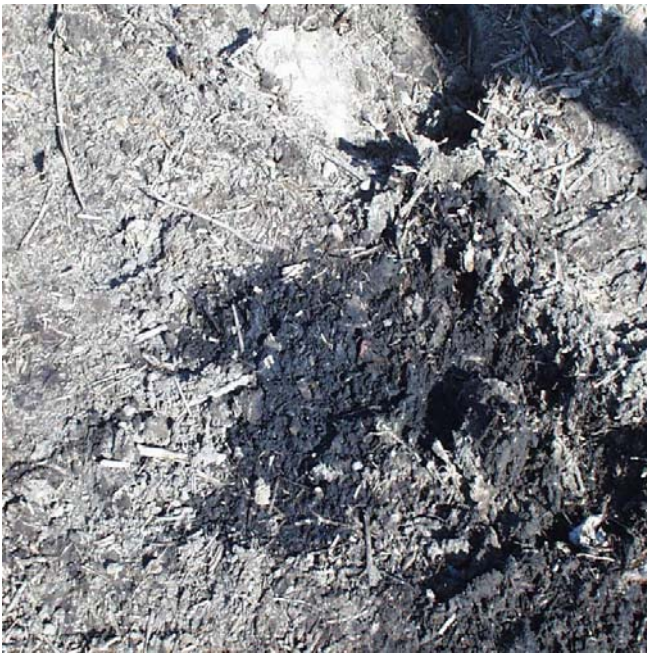
Areas of Inspection	Observation	Recommended Action
Blasting	site at this time 1/08/04	
Spills	<p>- A small spill was noted as an oily spot in the soil approximately 1-foot in diameter up near the Rt. 7 ramp. It is likely the result of equipment leaking during a boring that took place on Tuesday. 1/08/04</p> <p>- “Diapers” were noted under a generator near the upper trailers. 1/8/04</p>	<p>- The spill was marked and cleaned up immediately. The soil was bagged and disposed of properly. 1/08/04</p> <p>- The contractors should remain vigilant about securing and handling fuel containers due to the sensitivity of the area 1/08/04</p> <p>- Continue to keep all vehicles maintained well (i.e. no apparent fluid leaks) if they will be used or stored on site. 1/08/04</p> <p>- This practice is highly encouraged for any vehicle or equipment with a known leak. 1/08/04</p>
Additional/Miscellaneous Observations	<p>- A stone/traprock separator made of concrete blocks was constructed in the yard. 1/8/04</p> <p>- The lower hanging middle wires in the existing ROW have been relocated to the new poles along the Rt 7 ramp. 1/08/04</p> <p>- Excavation of the contaminated soil will begin next week. 1/08/04</p>

VIEW OF SMALL OILY SPOT NOTED NEAR

APPROPRIATELY PLACED "DIAPER" RT 7 RAMP. IT WAS CLEANED

IMMEDIATELY

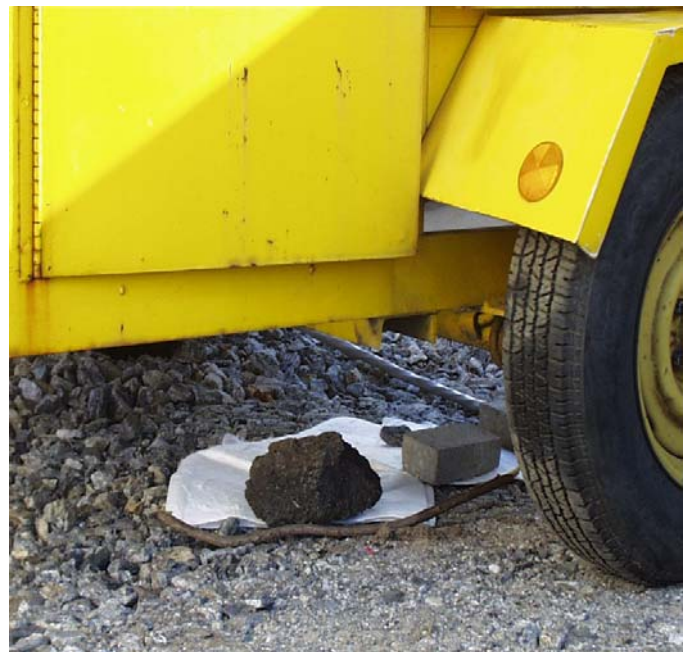
VIEW OF

UNDER POTENTIALLY LEAKING EQUIPMENT
